We installed an Englo IRIMETER-2 device that measures the roughness of the road surface on a Hyundai i30 and started our research, meaning that we drove through the road sections that piqued our curiosity in Tallinn and its surroundings. IRIMETER-2 is a class 3 measuring device, the information leaflet is attached to the letter. The tests were carried out by Englo's chief engineer Toomas Sõmer and mechatronics engineer Pent Laineste.

We decided to start by checking the roughness of the carriageway of the larger roads around Tallinn. For this purpose, we chose the Saku-Tänassilma road section (see Map 1 below), which doesn't have many intersections and the ones that are there are more isolated, with longer sections of roads without intersections. At the same time, these intersections are much larger than in the city and traffic management is therefore more complex. We used IRIMETER-2 to measure the roughness, i.e. the IRI, of these road sections in different weather and road surface conditions. The lower the IRI, the smoother the road surface.

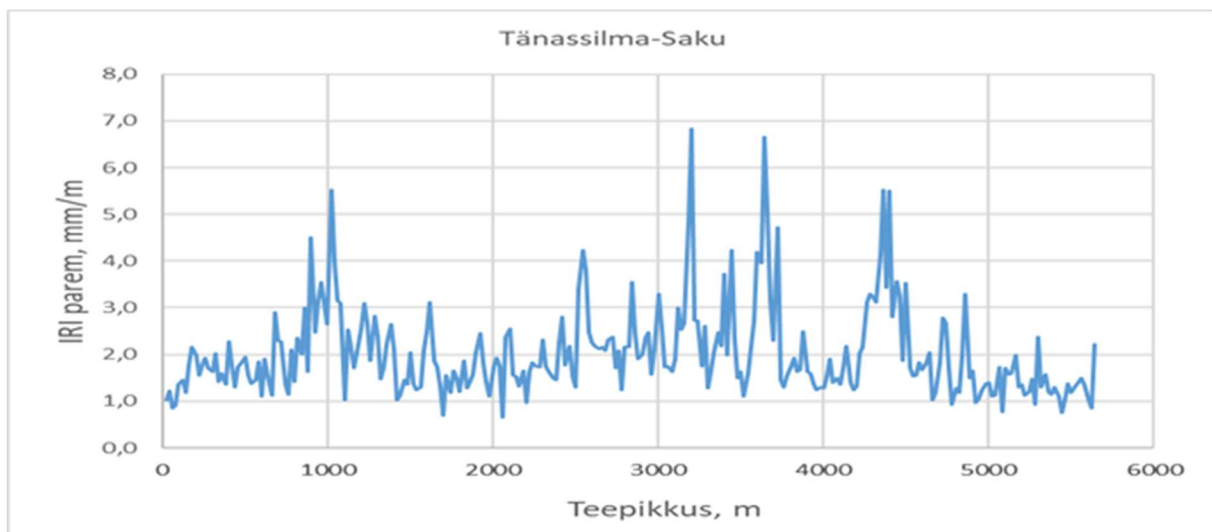
Graph 1. Tänassilma-Saku measurements 07.06.23, summer tires  
Map 1. Saku-Tänassilma road section

Graph 1 shows the results of the roughness measurement of the Tänassilma-Saku road section. A few road sections where the IRI is significantly higher, in some cases even reaching 4-4.5 mm/m, stand out in the graph. These road sections with high IRI values correspond to intersection or bridge crossings; in this test across the Vääna river (see Map 1). On straight road sections, the IRI ranges between IRI 1-1.5 mm/m. Surprisingly, however, when we assessed the roughness of the entire 5.7 km road section, the average IRI came to only 1.7 mm/m. The shorter the road section we needed to measure, the greater the impact of junctions on the average IRI. For example, measuring the road section between 3000-4000 m, the average IRI was already 2.5-3 mm/m. Worth remembering!

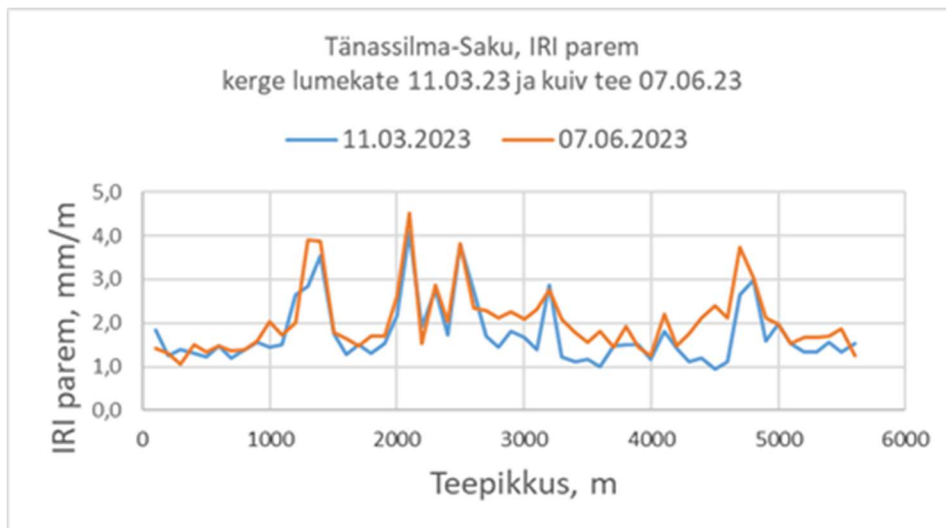
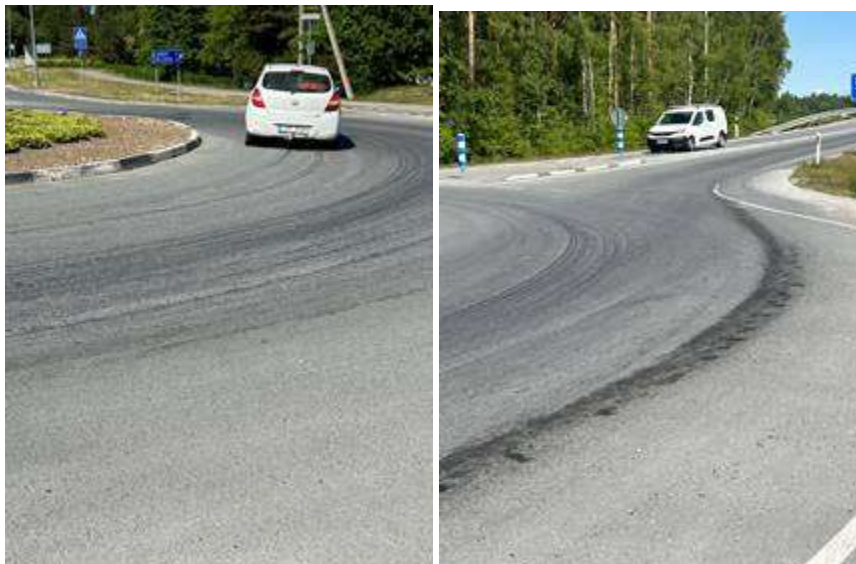
Graph 2. Tänassilma-Saku measurements, 11.03.23 and 07.06.23

It's quite interesting to compare two measurements, one taken in March when there was light snow on the Tänassilma-Saku road and the other in June when the road was dry, and people were already using summer tires. The comparison is shown in Graph 2. As you can see, the snow cover smooths the road a bit and the IRI is lower, but crossing the intersection has an even bigger impact. The differences in the mechanical properties of winter and summer tires certainly play a role in this as well. A smooth winter road can also mean that it's more slippery. It's a good idea to keep an eye on these things to ensure safe driving!

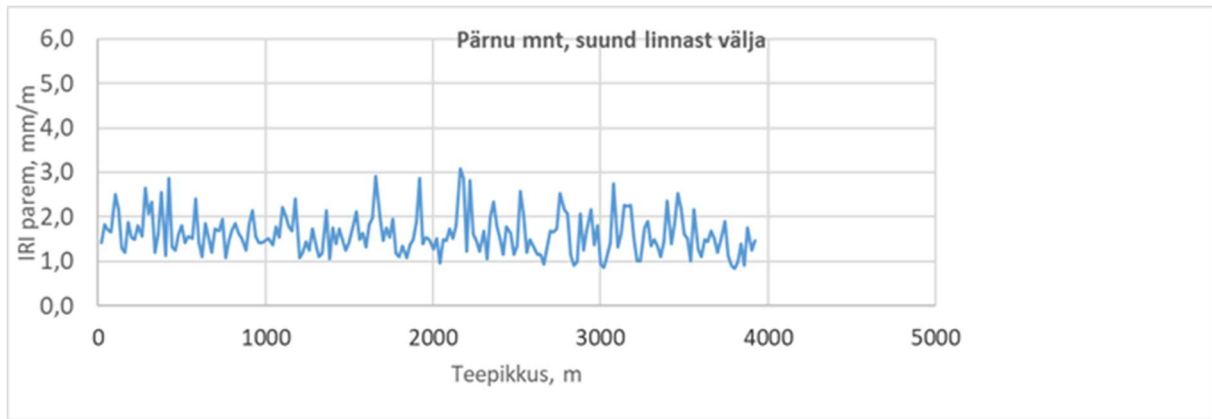
Graph 3. Pärnu road. Measuring  
Map 2. Pärnu road

We wanted to measure road surface roughness on a road where there are no side roads or intersections and where there is a smooth flow of vehicles. For this purpose, we chose the section of Pärnu Rd from the Tänassilma junction to the turn-off to Saue (see Map 2). The results are shown in Graph 3. The graph shows that on such road sections, the roughness of the road surface is more or less uniform, i.e. its rather rough. The vehicle had summer tires.

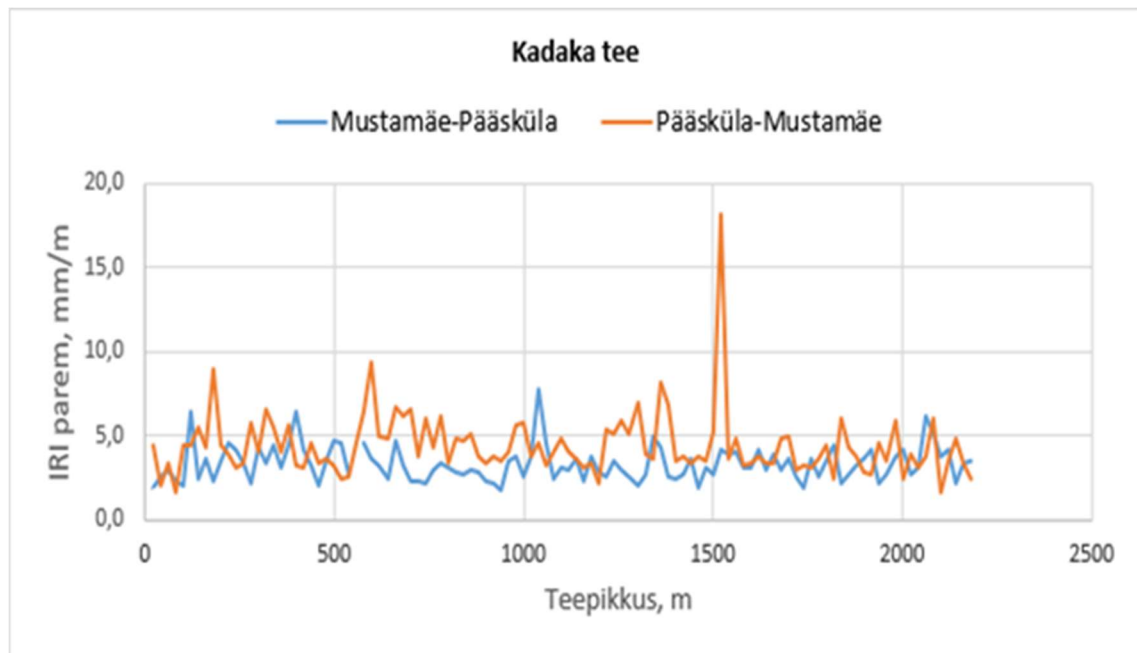
Graph 4. Kadaka Ave measurements on 09.06.23, summer tyres  
Map 3. Kadaka Ave

We see on Graph 4 that the IRI is significantly higher here, and this means that the roughness of the road surface is much worse than in the other tests above. But the traffic here is really heavy, with vehicles coming from Pääsküla congregating on Kadaka Ave, as well as vehicles leaving the city from the Mustamäe side towards Pääsküla in the opposite direction. This is particularly evident during

As we can see from the graph, the average IRI of the lane on Kadaka Road in the direction of Pääsküla-Mustamäe was 4.18 mm/m in this test, and slightly lower, 3.33 mm/m, in the direction of Mustamäe-Pääsküla. There are certainly a number of reasons for this, but one of them may be that there are more side streets leading into Kadaka Road on the lane to Mustamäe than on the lane from Mustamäe to Pääsküla. The measurements taken earlier in the spring with the same vehicle but with winter tires gave similar results.
